Degradation of **ASR** and **DEF** in concrete with International case studies

Yushan Gu (VTT), Elina Paukku (VTT)

11/02/2026 Siltatekniikan päiville

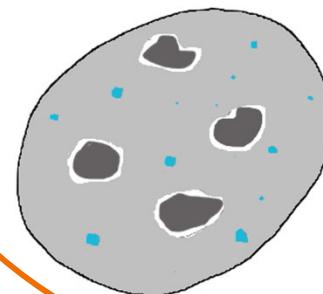
ASR is a harmful deterioration mechanism caused by the reaction between reactive **silica** in aggregates and **alkali** hydroxides (Na^+ , K^+ , OH^-) in concrete pore solution.

Alkali Silica Gel
formed around and within the aggregate structure

Alkali silicate hydrate gel (expansion)

The gel absorb water then expands and swelling gel over time

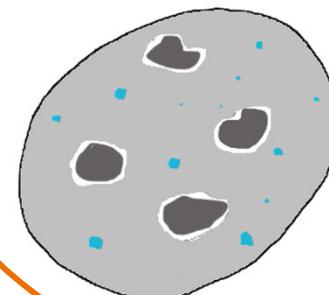
DEF is an internal swelling reaction (ISR) caused by the late formation of **ettringite** (AFt) in hardened concrete. AFt forms after an initial **high-temperature** phase has dissolved early-age AFt.

Ettringite formation (expansion)

The supersaturation pressure of AFt in pore solution drives concrete to expand

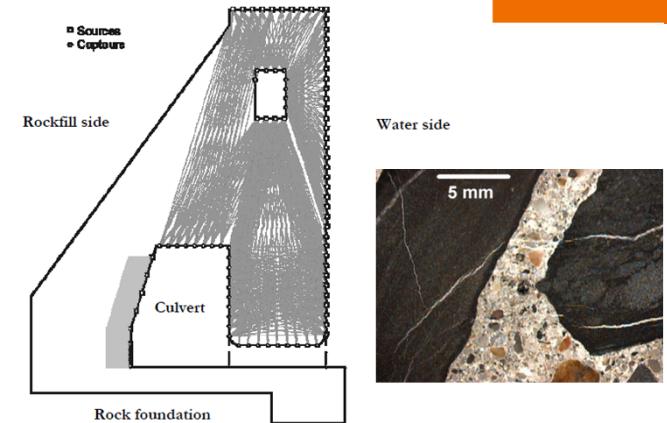
- Large hydraulic structure in Eastern Canada – ASR active for 30+ years
- Issue observed: cracking, surface deterioration, horizontal displacement
- Goal: assess condition + understand extent of ASR damage

- Major deterioration concentrated in upper 2 m of concrete
- Lower structure remains structurally sound with good mechanical properties
- Major tensile crack identified running from gallery toward surface
- ASR progression is slow, deep concrete largely unaffected

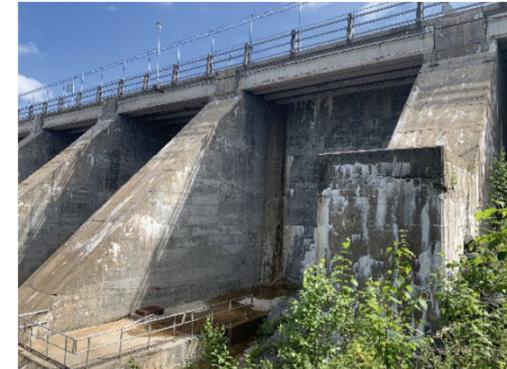
- Rapid-des-Îles (RDI) hydro-electric dam in Quebec, Canada.
- Built between 1965-1967.
- Affected by moderately severe ASR, with vertical expansion around 1mm/y.

- Misalignment of turbine-generator units
- Map-cracking and structural cracking
- Long-term premature aging of concrete infrastructure

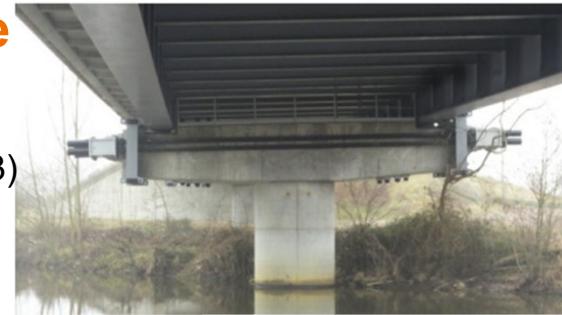
- DEF in a massive reinforced-concrete bridge pier column (France, 2003)
- Observed widespread cracking several years after construction
- Visual surveys reported map-cracking, crack coalescence along restrained zones, and measurable displacements consistent with internal swelling.

Cracking at the surface of the pier P1 (the thick lines correspond to injected cracks – crack width in mm).

Established spatial patterns and progression, highlighting restraint-driven crack orientations and zones of higher swelling.

- The bridge pier's distress was consistent with DEF-driven internal swelling: map-cracking, expansion-induced displacements, and core residual expansion.
- Exposure conditions (high humidity/wetting) and elevated early temperatures significantly influenced the observed movements and stress redistribution.
- FEM results reinforced the diagnosis by matching measured displacement fields with swelling inputs calibrated from residual expansion data.

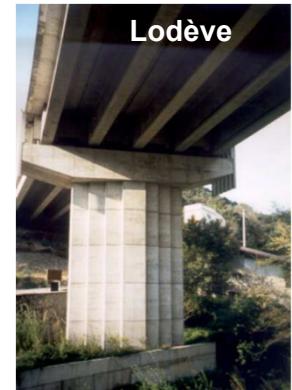
In France, several massive cast-in-place concrete structures — developed deterioration linked to DEF.

Ondes 1955	Bourgogne 1990	Lodève 1980	Bellevue 1988	Beynost 1982	Cheviré 1988/89
Structural part	Cap beam	Base of pylon	Cap beam	Pier	Cap beam	Base of pier
DEF Occurrence	27 yrs	6 yrs	9 yrs	10 yrs	10 yrs	8 yrs
Environment	Waterproofing Problem	Immersed & variable imme.	Lack of drainage	Immersed & variable imme.	Exposure to rains	Rains and capillarity
T max (°C)	80	79	80	80	69	75
W/C ratio	0.50	0.45	0.47	0.54	0.49	0.48
Cement type	CEM I	CEM I	CEM I	CEM II/A	CEM I	CEM II/A
Cement (kg/m ³)	430	400	400	380	350	385
SO ₃ (%)	2.5	2.8	2.6	2.5	3.4	2.5
C ₃ A (%)	11.2	8.2	9.8	7.0	10.4	7.0
